Canon SERVICE REPORT

NO. R-5003E-1/2

MODEL: Canola SX-100 & SX-300

SUBJECT: Modification to stabilize oscillator circuit

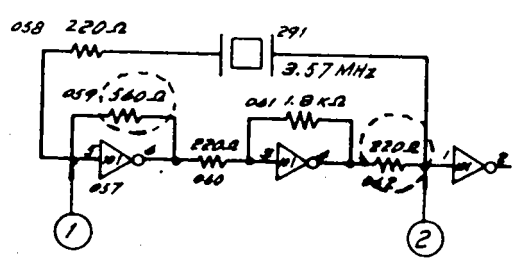
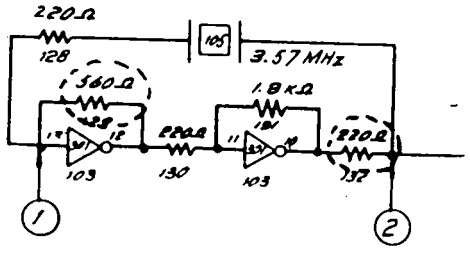
Outline : It was found that the machines didn't work when frequency of crystal oscillator was changed from pre-set one. (3.57 MHz). Therefore, 2 resistors in oscillator circuit are changed to avoid above mentioned trouble.

Modification:
Changed resistors in oscillator circuit are as follows.

Original.

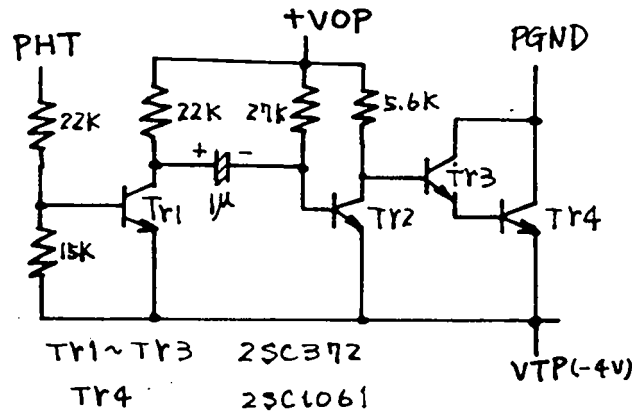
- Added "Protection Circuit"

Outline : It was found that a thermal print head might be broken when short circuit was made by accidental operation of a probe while repairing defective machines. Therefore, a "Sub-printed Board" for "Protection Circuit" is being added in a "Printer Unit" as shown below.
