Canon SERVICE REPORT

NO. R-5003E-1/2

MODEL: Canola SX-100 & SX-300

SUBJECT: Modification to stabilize oscillator circuit

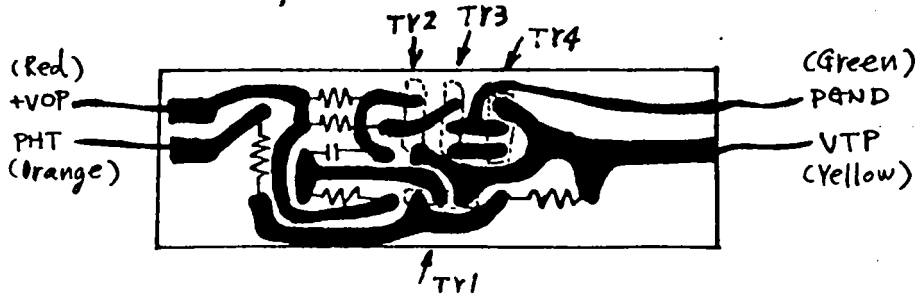
Outline : It was found that a thermal print head might be broken when short circuit was made by accidental operation of a probe while repairing defective machines. Therefore, a "Sub-printed Board" for "Protection Circuit" is being added in a "Printer Unit" as shown below.

- A "Sub-printed Board" for "Protection Circuit"
